## Sansui Europe Service Information

SSI-0004E

Models : - 9090, 8080

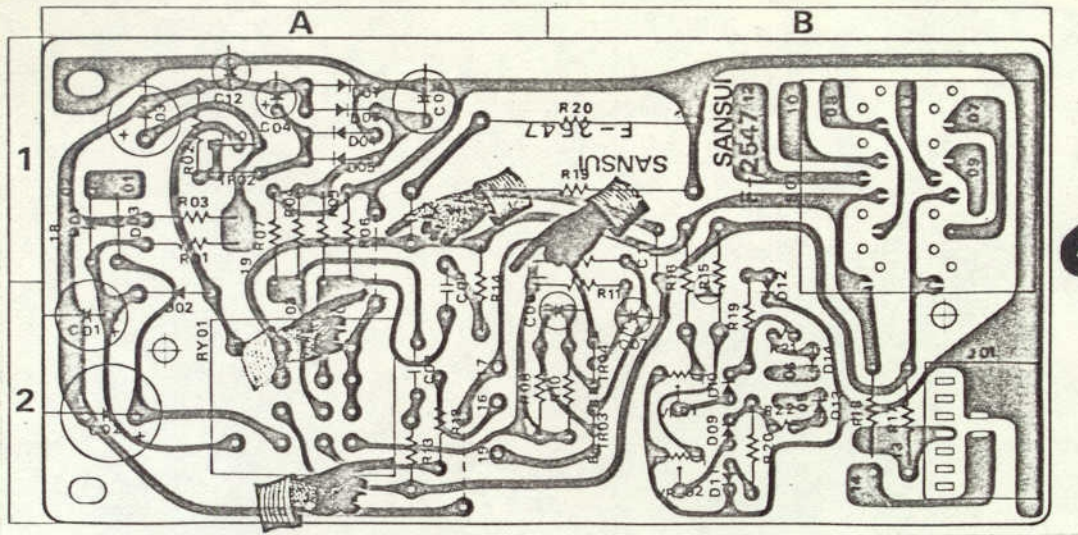
FIG. 1

In these models it may happen sometimes that one or both channels get broken. In this case it is possible that the protector relay gets broken by contacts which are melted. It may also happen that some conducting lines on P.C.B. F-2547 burn out by an excessive external (over)load, f.i. when as well the "A" as the "B" speakers are switched on.

- Resistors R13 and R14, 10 Ohms have to be replaced by special fusing resistors of 4.7 Ohms 1/2 W. See fig. 1.
- The jumper connecting some relay contacts to earth, as shown in fig. 1, has to be removed.

1. To protect the P.C.B. F-2547, the following points have to be done :

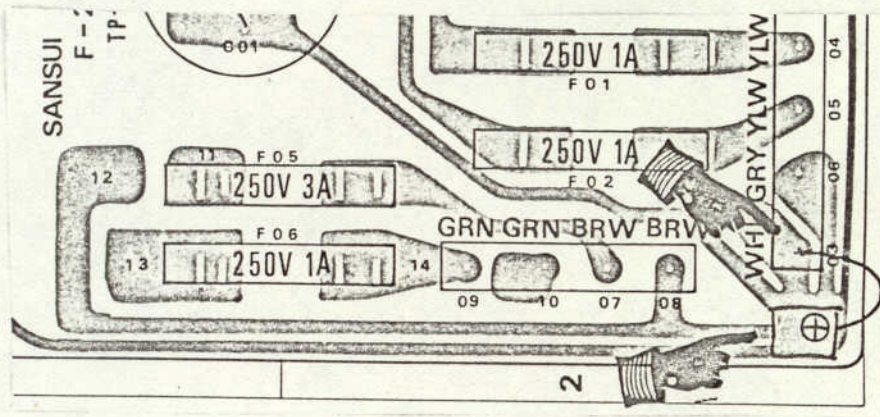
FIG. 2

3. The earth contact on P.C.B. F-2546 can be ameliorated by soldering a piece of mesh-lead or any piece of thick, well-conducting wire, from point O3 ( or O6 ) to the adjacent earth lug, as shown in fig. 2.

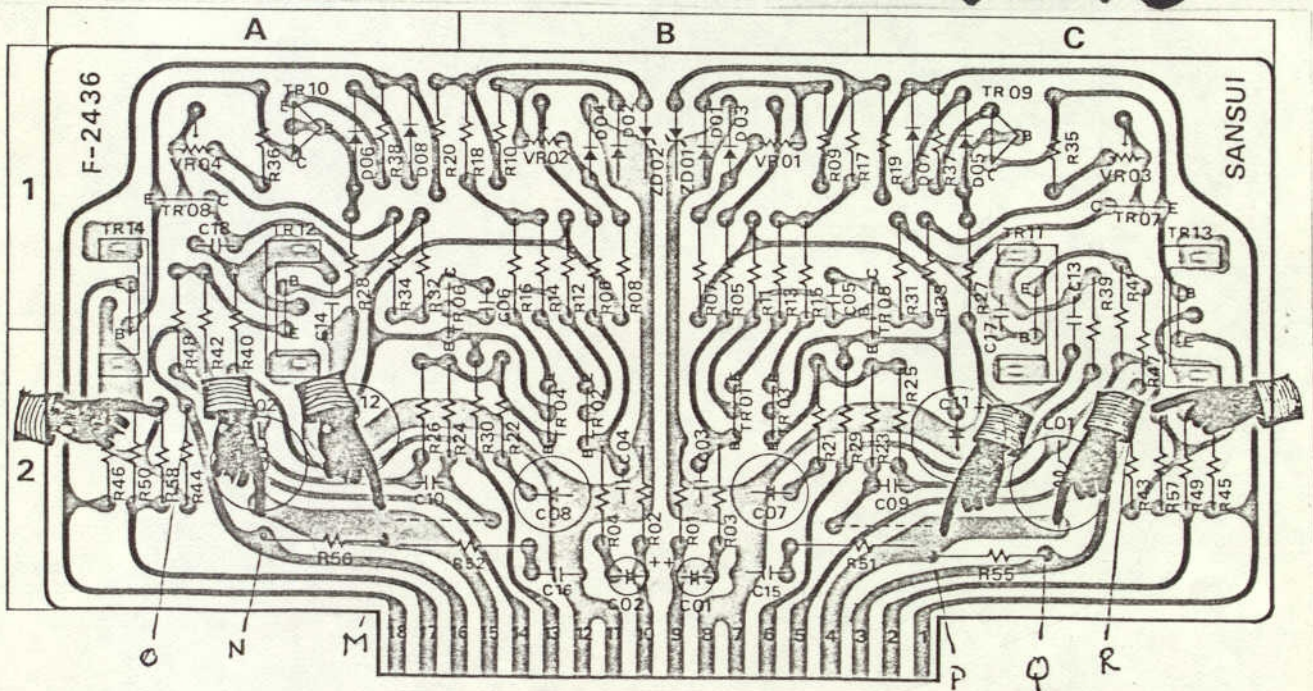
FIG. 3

- Connect one wired-in fuse from point M on P.C.B. F-2436-1 ( See fig. 3 ) to point N or to point O, depending upon the position of resistor R44.

- Connect one wired-in fuse from point P on P.C.B. F-2436-1 ( See Fig. 3 ) to point Q or to point R, depending upon the position of resistor R43.

- Check on P.C.B. F-2436-1 if the two points of coils L01, 02 are connected by a jumper.

If so, please remove the jumper.

- Fix the fuse labels to the print on the adequate places.

for 9090 : 7A wired-in fuse + label

for 8080 : 6A wired-in fuse + label

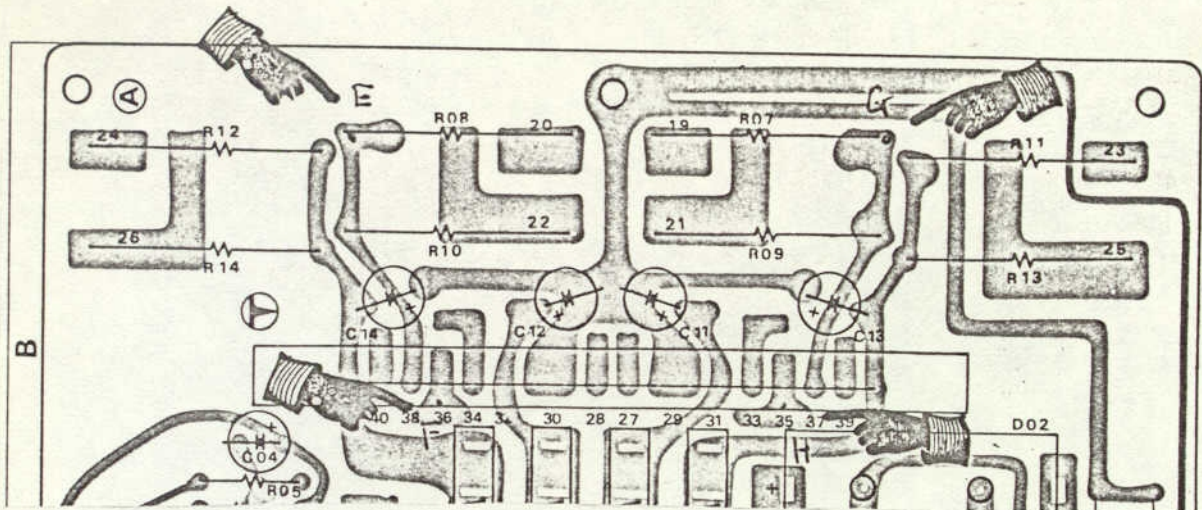
FIG. 4

- It is also possible that these connections are made, like shown on fig. 4, from point E to point F and from point G to H. Even so these jumpers should be removed.

- On the original prints F-2546 there is a jumper between points 38 and 36, and between points 37 and 35. Those jumpers have to be removed.

- Make the following connections with normal wire :

- from point 04 on F-2547 to point 35 on F-2546

- from point 03 on F-2547 to point 36 on F-2546
